Technical Report M10

**SEDIMENTATION STUDY OF THE MISSOURI RIVER,  
COPELAND BEND  
Miles 569 to 564.5**

**HYDRAULIC MICRO MODEL INVESTIGATION**

Final Report – September, 1999

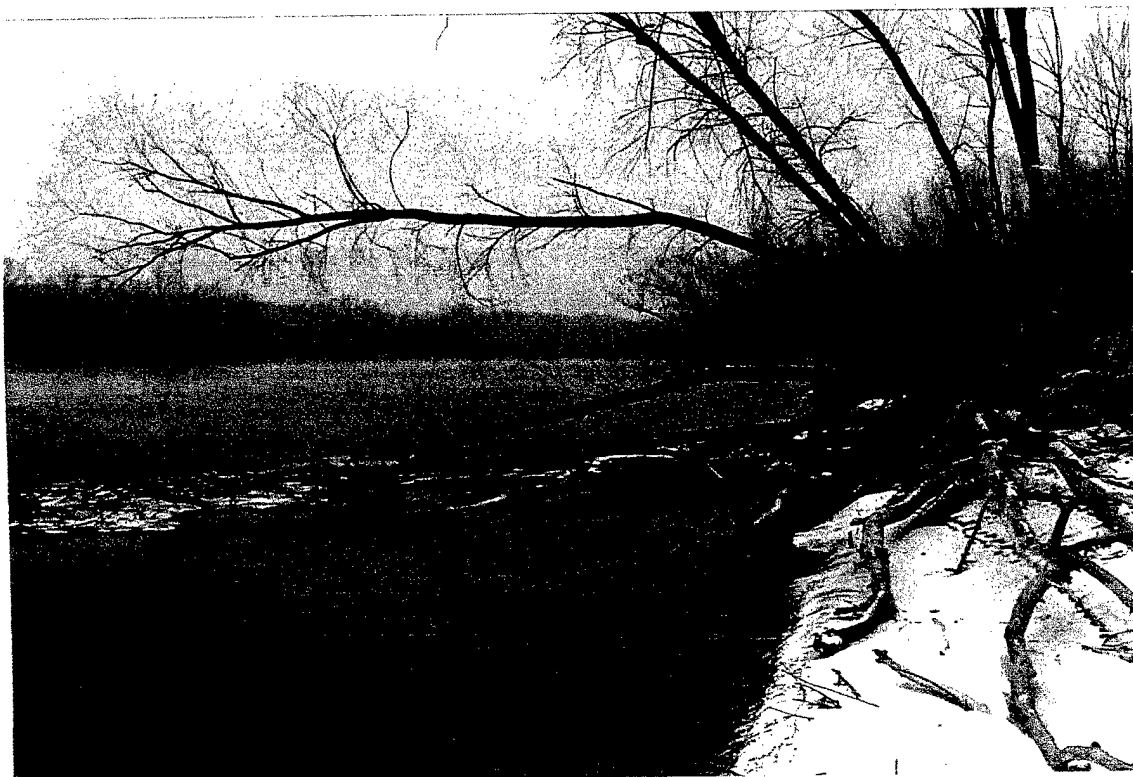
5

**Copeland Bend, Looking Upstream at Dike 612.5**

In December of 1998, river engineers from the St. Louis District made a field investigation of the study reach. Plates 4 through 10 are photographs taken during this inspection. The following observations were noted:

- All of the dikes were angled slightly downstream, which has caused small bankline roundouts to occur below each structure. The bankline roundouts appeared to be stable, however, and the integrity of the dikes was not in jeopardy.
- An unusual amount of mature trees were destroyed near and along the left descending bankline due to beaver impacts. This could cause future lateral erosion of the existing bankline.

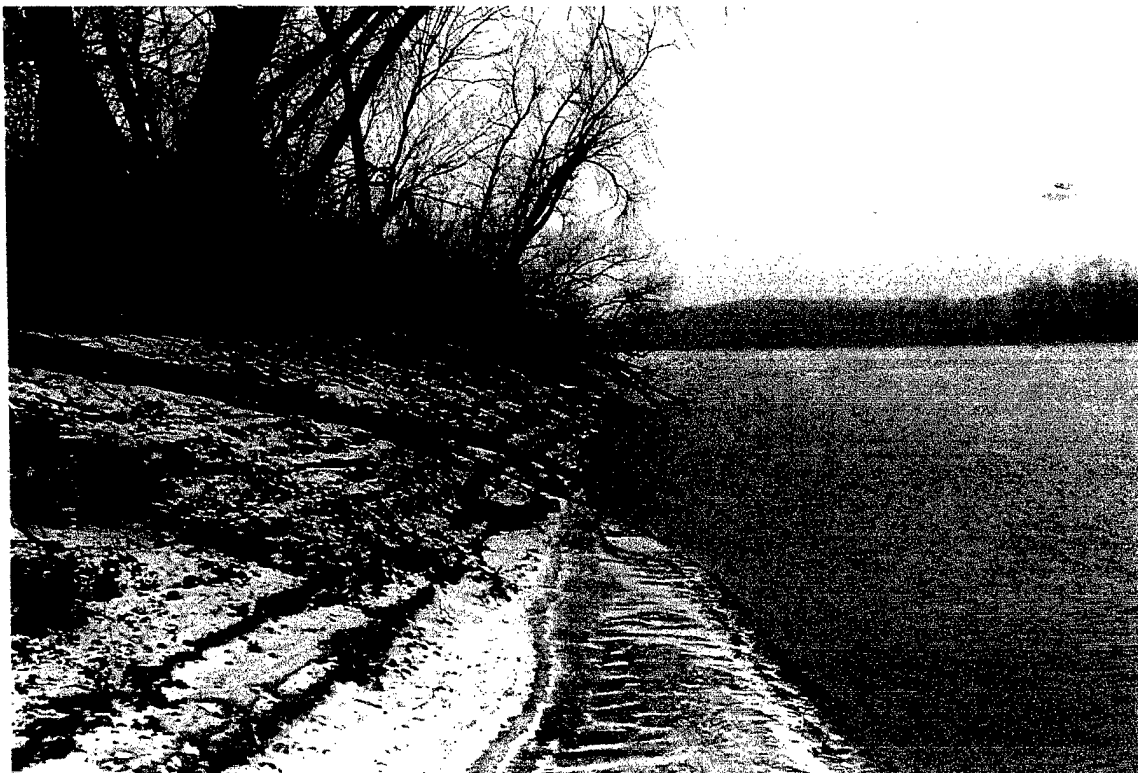
7

**Copeland Bend, Looking Downstream From Dike 612.5**

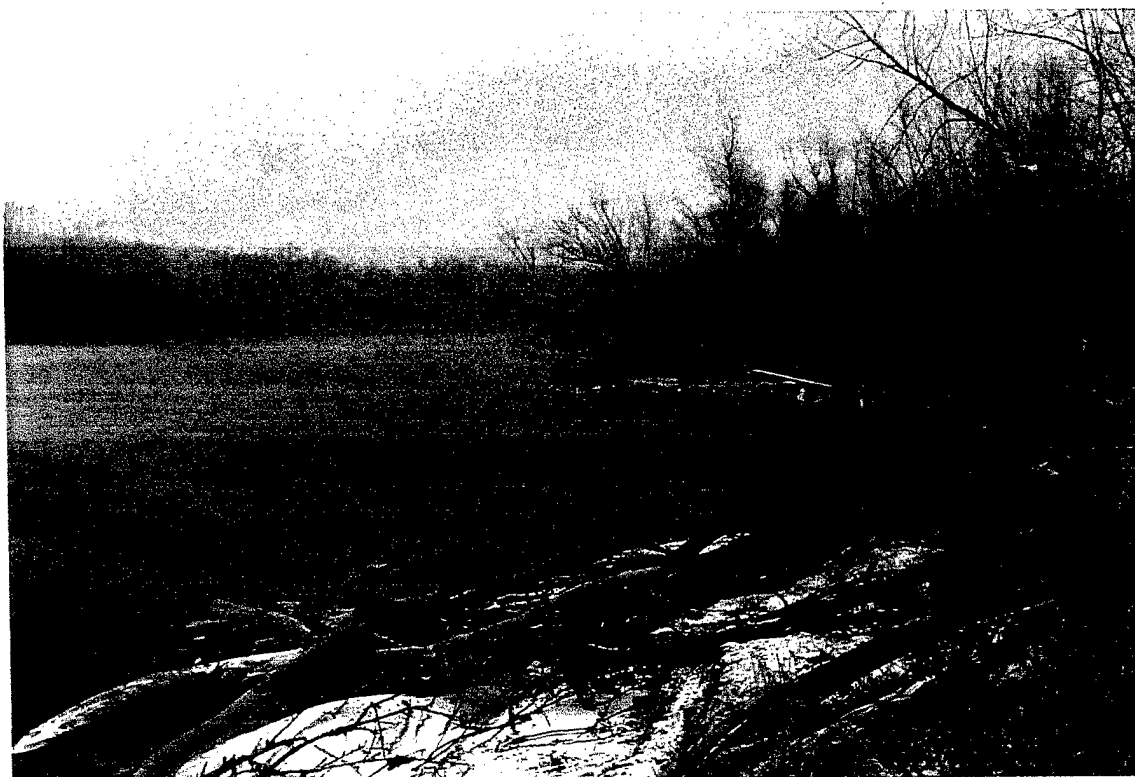
8

**Copeland Bend, Looking Upstream at Dike 612.6**

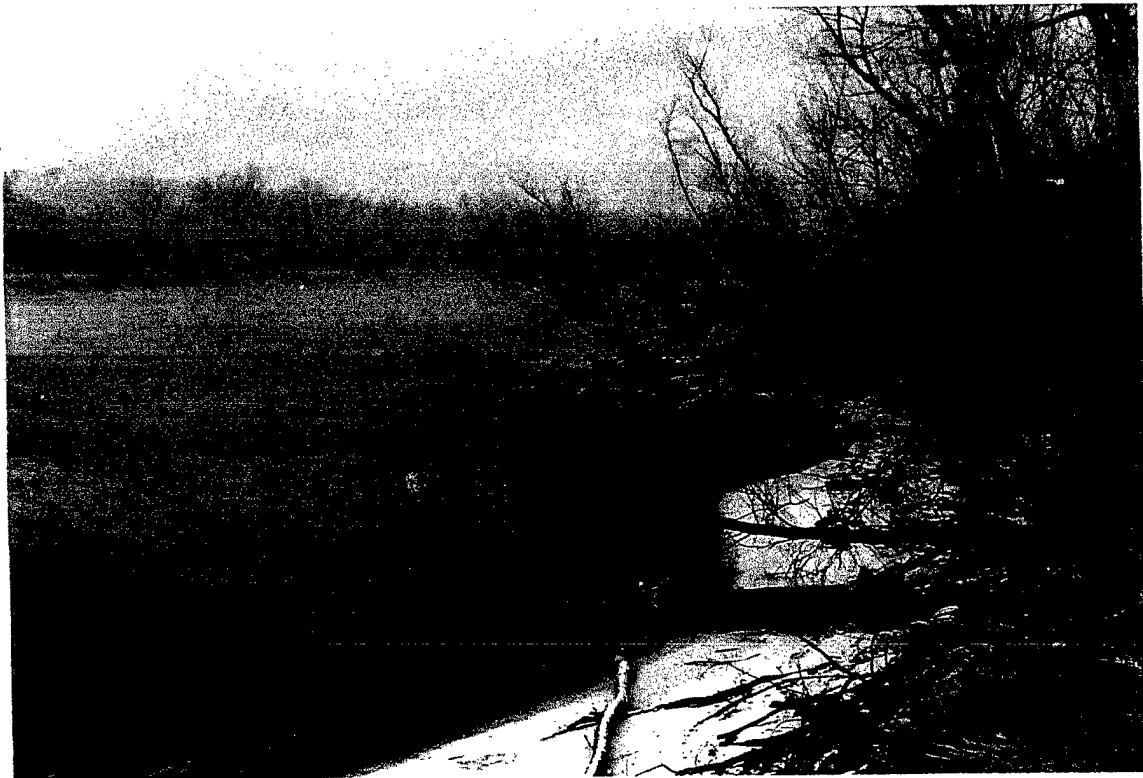
10

**Copeland Bend, Looking Upstream at Dike 612.7**

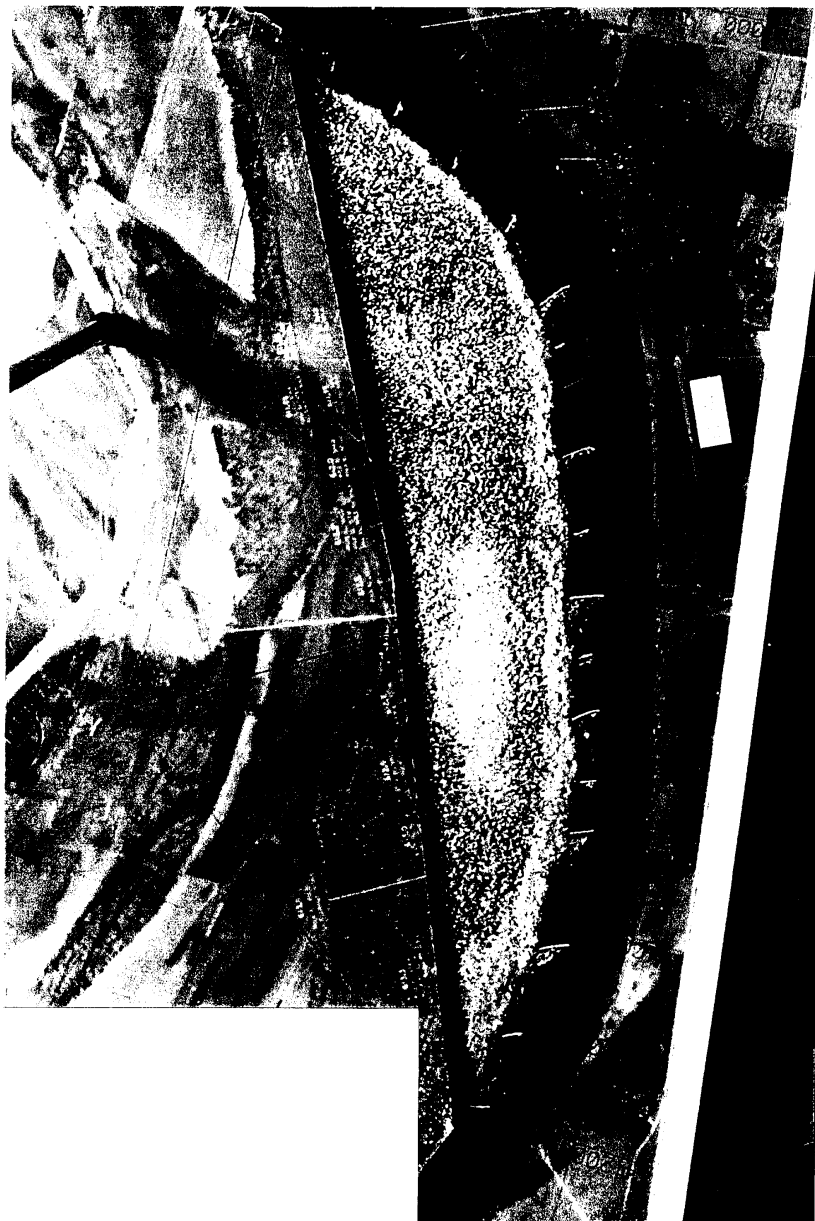
Sheet No. 16

Plate 16 shows the flow visualization of the base test. All flow visualization photographs were captured throughout the model tests with the stage of the model at approximately + 2 CRP. Results indicated that the flow through the study reach was distributed fairly uniformly in the navigation channel, between the ends of the dikes and the right descending bankline, except at Mile 566.0, where flow was more concentrated at the apex of the bend adjacent to the point bar. The influence of the dikes in diverting flow away from the left descending bank and generating eddies was observed in the model. Flow visualization did not capture the eddies, however, the visualization did show the relative slower moving water within the dike field.

Base Test

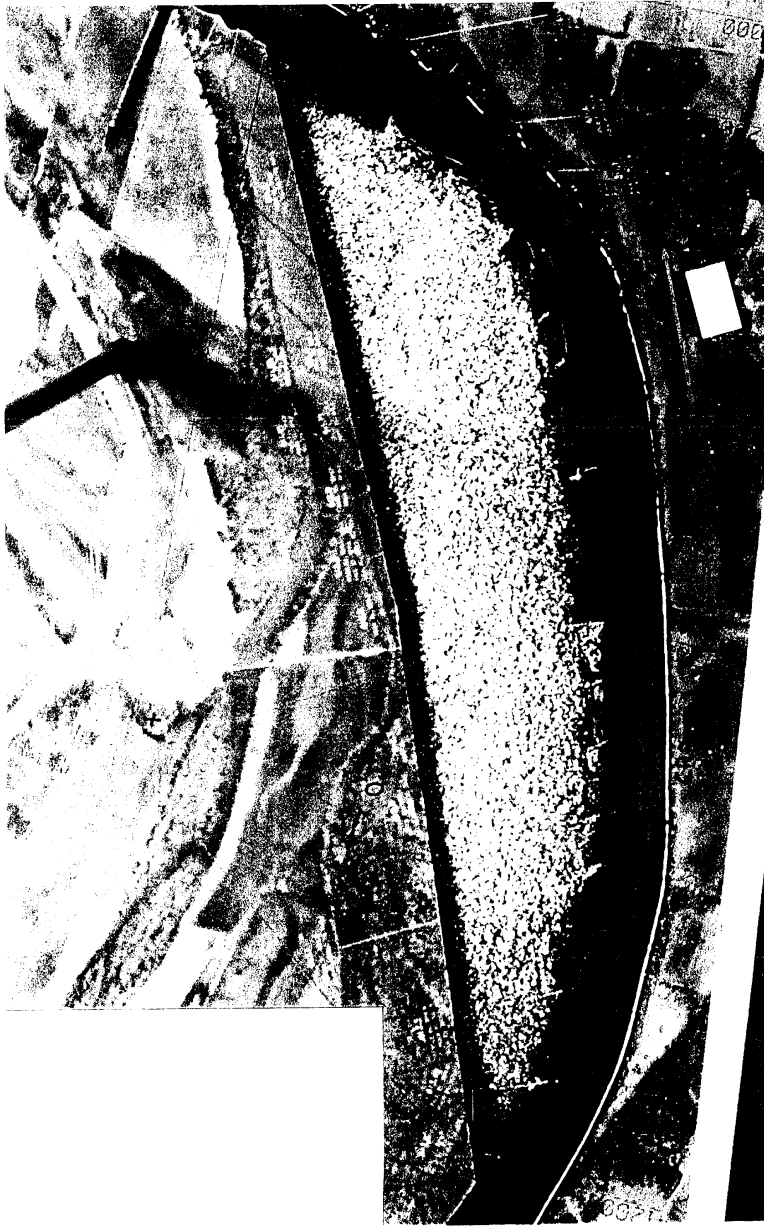
Flow visualization showed that flow distribution through the main channel was similar to the base test. Flow still had a tendency to be concentrated at the apex of the bend at Mile 566.0. A greater amount of flow was observed within the dike fields as compared to the base test.

U.S. ARMY ENGINEER DIVISION, NORTHWESTERN CORPS OF ENGINEERS OMAHA, NEBRASKA
PREPARED BY: A. HODGE CHECKED BY: S. DAWSON DATE: JAN 1990	Sedimentation Study, Missouri River Copeland Bend, Flow Visualization Alternative 1 Degrade All Dikes to -2 CRP Scale: 1" = 100' DATE: 19

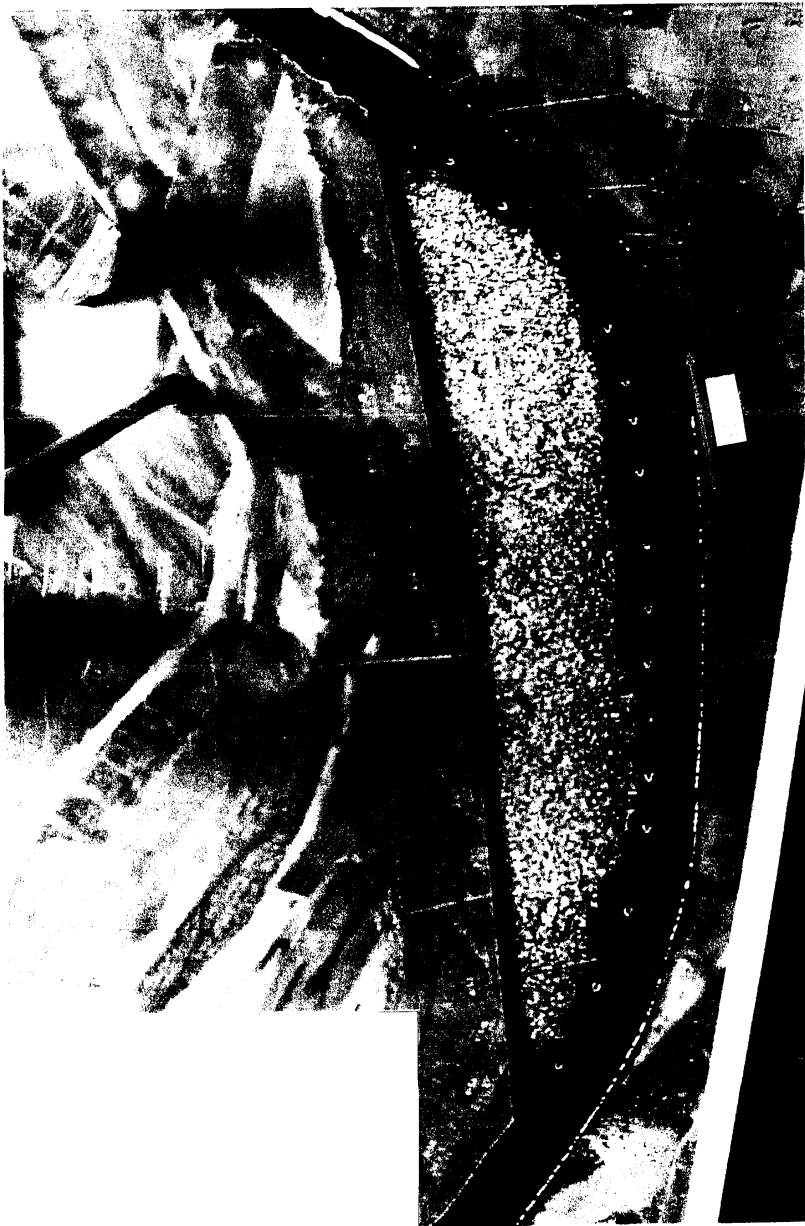
Sedimentation Study, Missouri River  
Copeland Bend, Flow Visualization  
Alternative 2

0 100 200  
Degraded All Dikes to -2 CRP, Chevrons at +2 CRP

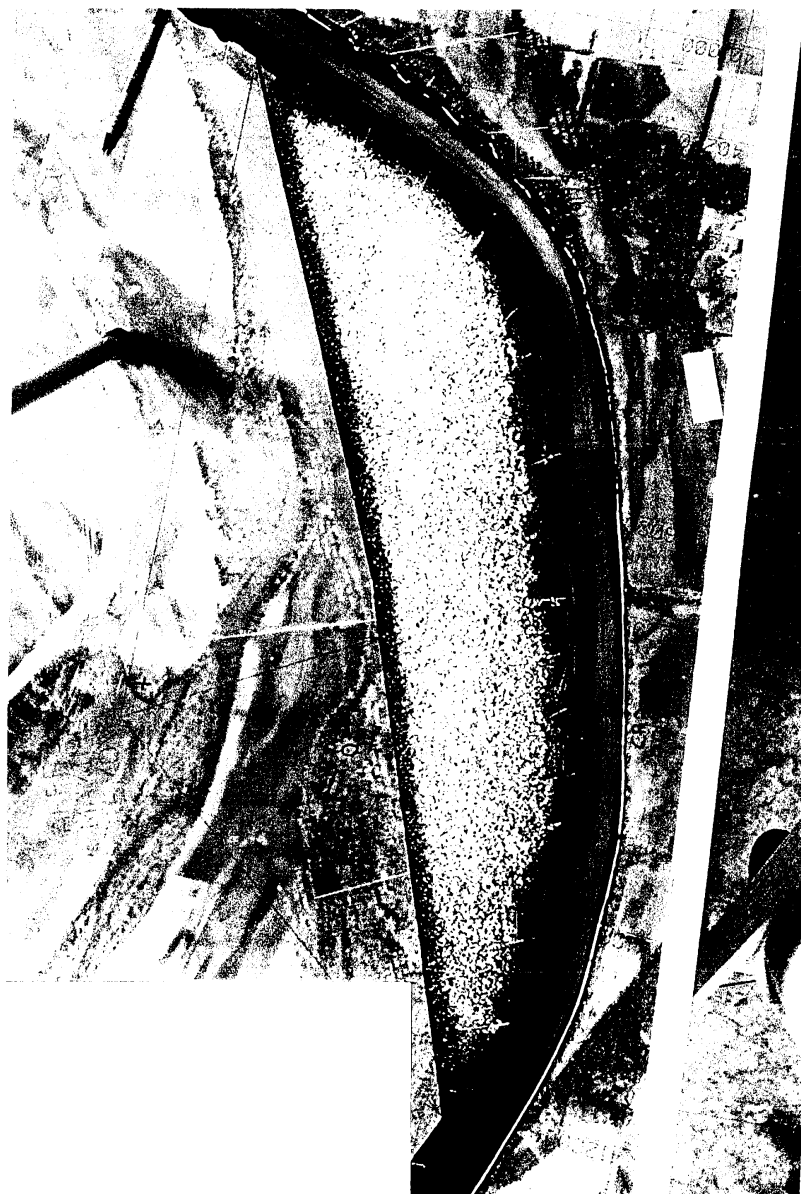
Degrade Alternating Dikes 10 - 2 CRP
PLATE NO. 25

U.S. ARMY ENGINEER DIVISION, NORTHWESTERN CORPS OF ENGINEERS OMAHA, NEBRASKA
PREPARED BY: R. D. Dwyer CHECKED BY: J. G. Gorman DATE: 1 FEBRUARY 1952	Sedimentation Study, Missouri River Copeland Bend, Flow Visualization Alternative 3

**Alternative 3. Degrade Alternating Dikes To -2 CRP.** Alternative 3 involved the degradation of alternating dikes along the left descending bank. Results (Plates 23, 24, 25) indicated the following trends:

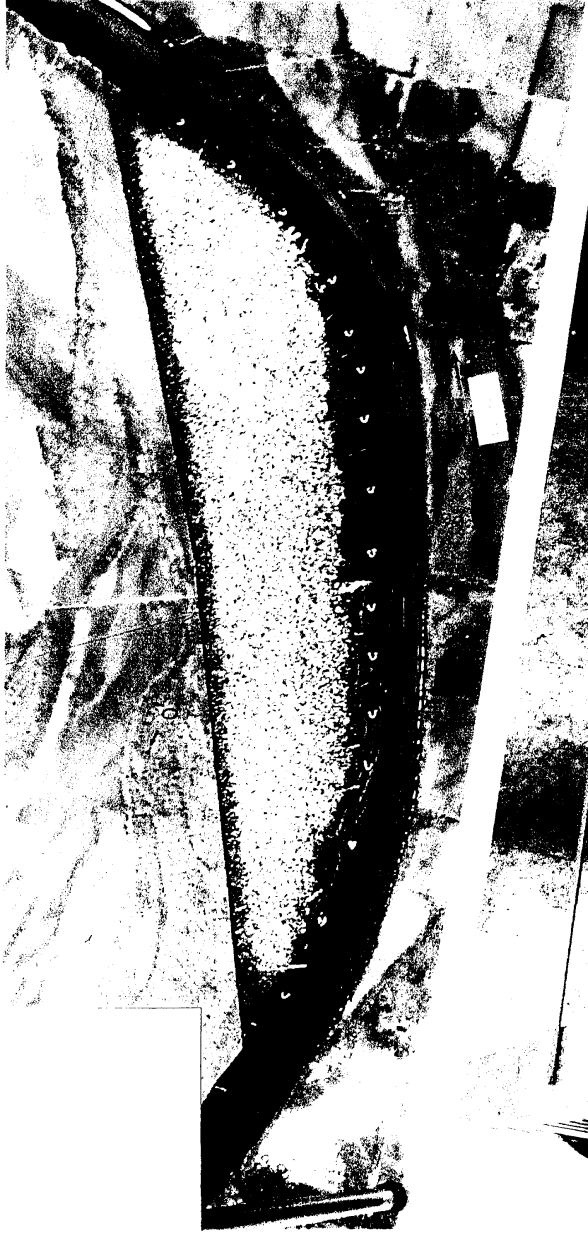
Flow visualization showed that flow distribution through the main channel was similar to the base test. Flow still had a tendency to be concentrated at the apex of the bend at Mile 566.0. Results also indicated that more flow was distributed over the dike fields as compared to the base test. In addition, some of the chevrons produced flow "shadows" directly downstream of each structure as a result of individual boundary effects, similar to what was observed in the previous Alternative 2.

U.S. ARMY ENGINEER DIVISION, NORTHWESTERN CORPS OF ENGINEERS OMAHA, NEBRASKA	
	Sedimentation Study, Missouri River Copeland Bend, Flow Visualization Degrade Alternating Dikes to -2 CRP Chevrans at +2 CRP Alternative 4	
PREPARED BY: R. Gwynne CHECKED BY: D. Gwynne DATE: 11 FEBRUARY 1988	DATE NO. 28

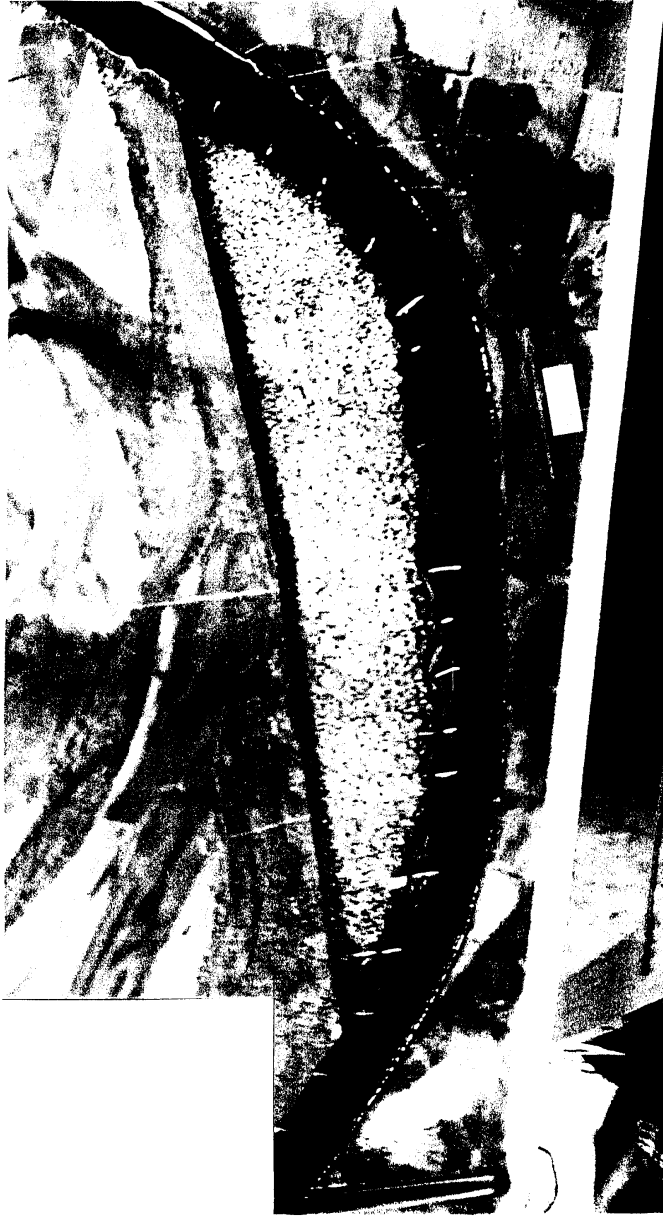
U.S. ARMY ENGINEER DIVISION, NORTHWESTERN CORPS OF ENGINEERS OMAHA, NEBRASKA
PREPARED BY: R. D. Dwyer CHECKED BY: D. Dwyer DATE: FEBRUARY, 196	Sedimentation Study, Missouri River Copeland Bend, Flow Visualization Alternative 5 50' Landward Notch at 5 CRP
PLATE NO. 31
